**NORFOLK Z-LOOP REPAIR
PROJECT COMPLETION REPORT**

**FPO-1-83(27)
AUGUST 1983**

This report describes the repairs to the Z-loop in Slip #2 at the Norfolk Deperming Facility, Naval Station, Norfolk, Virginia. The repair design and installation were the responsibility of the Ocean Engineering and Construction Project Office of the Chesapeake Division, Naval Facilities Engineering Command (CHESNAVFACENGCOM). The repairs were carried out by personnel of Underwater Construction Team One (UCT-ONE).

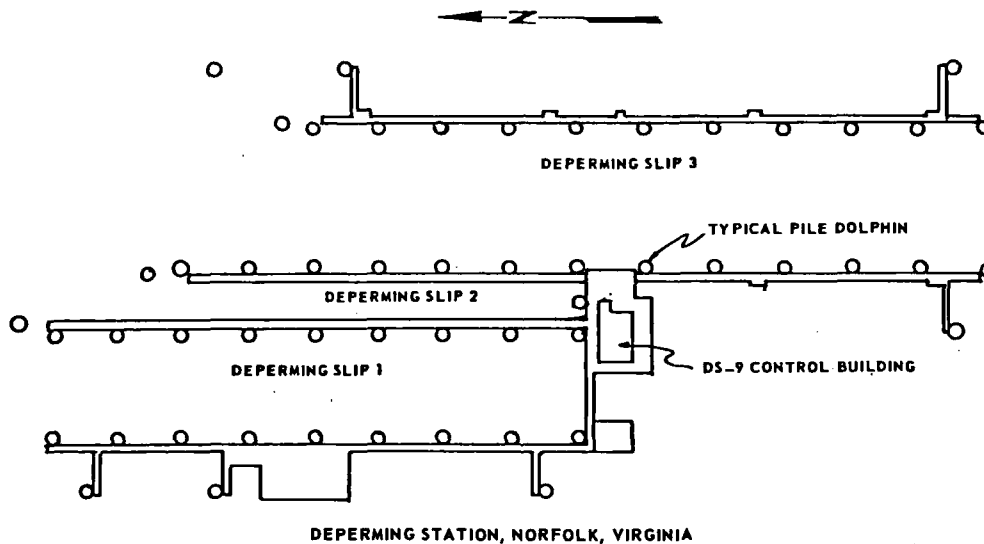
FIGURE 1-1

The Deperming Facility is a free-standing complex of timber piers arranged to form three slips, Figure 1-1. Its purpose is to impress magnetic fields on surface vessels and submarines in order to relieve any residual permanent magnetic field retained by the ship after initial construction, overhaul periods, and deployment periods. The facility is lo-

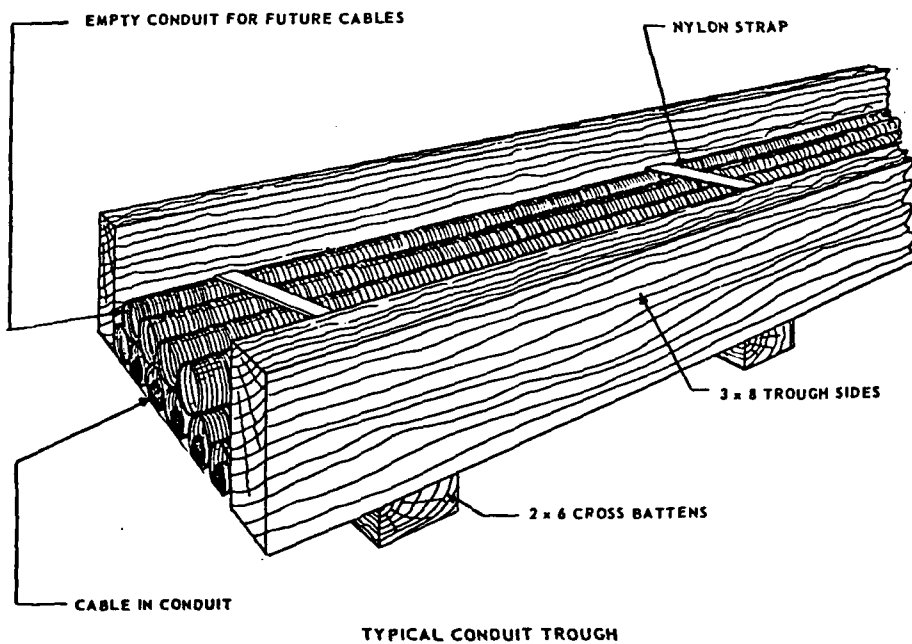
FIGURE 1-3

The trough sections, which fitted between bents on the piers, were fabricated on site, because variations in the bent spacing dimensions precluded prefabrication. A total of sixty 20-foot sections were built and installed. The MK 12 diving gear was used for this phase. The nine conduit-enclosed cable sections, each 750 feet long, were pulled into place under the pier by SCUBA divers, lowered into the trough and secured. The eleven empty conduits for future cable were installed in the same manner, Figure 1-3.

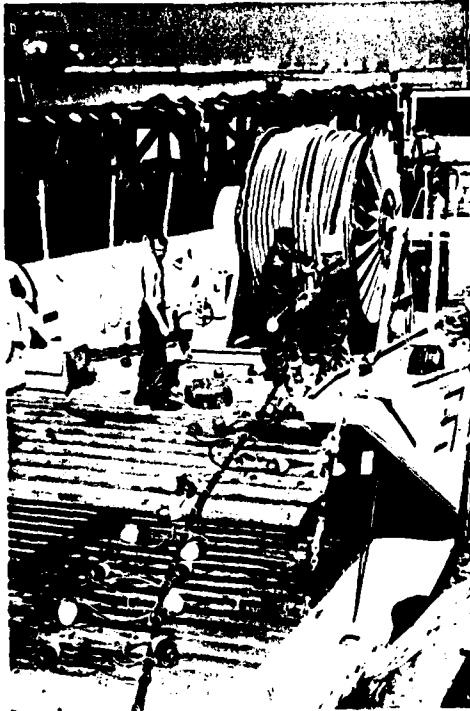
FIGURE 4-10

Although one cable was installed in this manner, the flotation was not successful. The hollow plastic floats were found to support only four pounds each -- the approximate weight of a foot of cable -- instead of the anticipated nine pounds. The floats also tended to collapse when only slightly submerged. A check with vendors in the area indicated that suitable floats were available and a quantity was ordered, but some delay ensued in obtaining them. An abortive attempt was made to fill the hollow floats with plastic foam, but the available aerosol foam proved to be hygroscopic.

REELING CONDUIT OFF LCM-8
USING INITIAL SET OF FLOATS
WHICH WERE INCAPABLE OF
SUPPORTING THE LOAD

At this juncture, UCT-ONE personnel suggested removing the cables from the conduit, pulling the empty conduit into place and then pulling the cable back into the installed conduit. This was tried. The cable/conduit assemblies were fed off the reel and laid out along the deck of the catwalk. The conduit was stopped off and the powered cable reel was used to pull the cable out of the conduit, with a polypropylene messenger line attached. The empty conduit was then wound on the reel, and fed under the catwalk by SCUBA divers. The divers found it relatively easy to handle the empty conduit. The messenger line was brought through the sheaves to the gypsy head on the

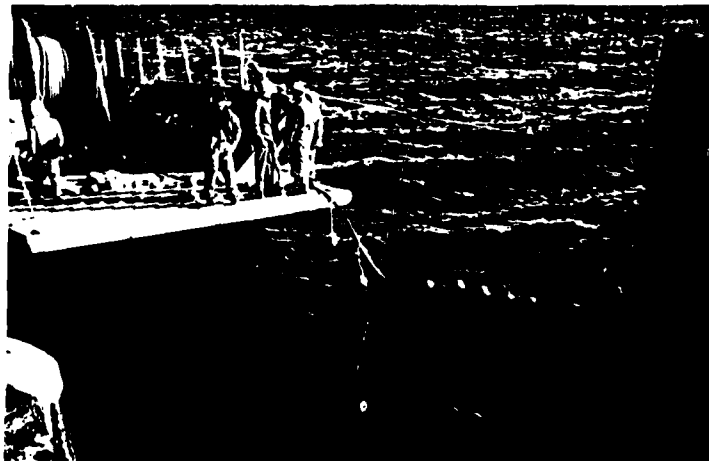
FIGURE 4-11

REELING CONDUIT OFF LCM-8 ON SECOND
SET OF FLOATS WITH SATISFACTORY
CABLE SUPPORT CAPABILITY

Meanwhile, new floats of two types were delivered. These were nine-inch diameter spherical plastic foam and cast aluminum floats. Both types proved quite satisfactory. The installation technique was slightly modified and the remaining cables were installed without major difficulty. The LCM-8 was moored to the opposite side of the slip at a sufficient distance to allow 75 to 100 feet of cable to be floated in the water before reaching the pier, Figure 4-11. Several swimmers in this area adjusted the buoyancy by varying the spacing of the floats. The cables were then pulled into place and temporarily secured. After the cables were in place, the SCUBA divers released the floats and the floats were picked up by men in a boat. The divers guided the cables into place in the trough and brought the ends of the conduit into position. At the ends of the pier, the flexible conduits were clamped to a support bracket and the cable was brought to the surface through a rigid PVC tube which was coupled to the flexible conduit and supported by additional brackets. The Kellems grip used to pull the cable was left attached to the cable and was anchored to an eyebolt through one of the pier structural members.
